Prüfbericht - Nr.: 11032874 001		Seite 1 von 2 Page 1 of 2			
<i>Test Report No.:</i>					
Auftraggeber: <i>Client:</i>	Yi Chi Hsiung Ind. Corp. No. 51, Lane 40, Beitang Rd. Homei Township, Changhua County, Taiwan				
Gegenstand der Prüfung: <i>Test item:</i>	Swing seat				
Bezeichnung: <i>Identification:</i>	P1017DWR	Serien-Nr.: <i>Serial No.:</i>	Engineering Samples		
Wareneingangs-Nr.: <i>Receipt No.:</i>	A000009765	Eingangsdatum: <i>Date of receipt:</i>	2013, Apr, 08		
Zustand des Prüfgegenstandes bei Anlieferung: <i>Condition of test item at delivery:</i>		Apparently Good			
Prüfort: <i>Testing location:</i>	TÜV Rheinland Taiwan Ltd., Taichung Branch Mechanical Laboratory No.9, Lane 36, Sec. 3, Minsheng Rd., Daya District, Taichung City 428, Taiwan, R.O.C.				
Prüfgrundlage: <i>Test specification:</i>	According to client's specification.				
Prüfergebnis: <i>Test Result:</i>	See test result

Prüfbericht - Nr.: 11032874 001

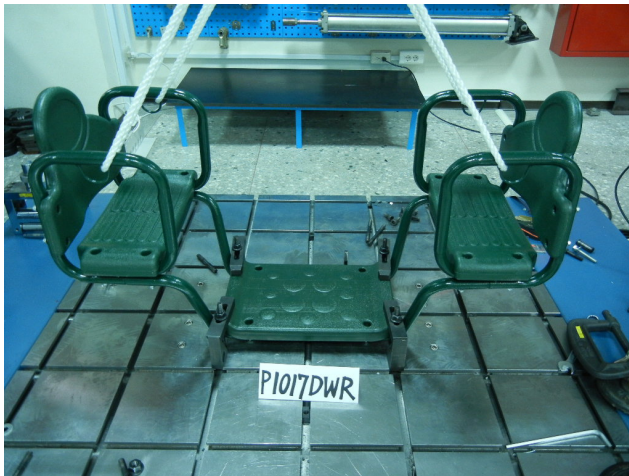
Picture 1

Clause	Requirement	Remarks	Verdict
1	Pulling test Check the breaking force for the sample.	By reaching force 6510 N (664 kg), the sample is strongly deformed and lose its function. The test setup and result please refer to picture 1 and 2.	--
