Prüfbericht - Nr.: 11032874 011		Seite 1 von 2 Page 1 of 2			
<i>Test Report No.:</i>					
Auftraggeber: <i>Client:</i>	Yi Chi Hsiung Ind. Corp. No. 51, Lane 40, Beitang Rd. Homei Township, Changhua County, Taiwan				
Gegenstand der Prüfung: <i>Test item:</i>	Swing seat				
Bezeichnung: <i>Identification:</i>	RT1140-17	Serien-Nr.: <i>Serial No.:</i>	Engineering Samples		
Wareneingangs-Nr.: <i>Receipt No.:</i>	A000009765	Eingangsdatum: <i>Date of receipt:</i>	2013, Apr, 08		
Zustand des Prüfgegenstandes bei Anlieferung: Condition of test item at delivery:	Apparently Good				
Prüfört: <i>Testing location:</i>	TÜV Rheinland Taiwan Ltd., Taichung Branch Mechanical Laboratory No.9, Lane 36, Sec. 3, Minsheng Rd., Daya District, Taichung City 428, Taiwan, R.O.C.				
Prüfgrundlage: <i>Test specification:</i>	According to client's specification.				
Prüfergebnis: <i>Test Result:</i>	See test result				
Prüflaboratorium: <i>Testing Laboratory:</i>	TÜV Rheinland Taiwan Ltd., Taichung Branch Mechanical Laboratory No.9, Lane 36, Sec. 3, Minsheng Rd., Daya District, Taichung City 428, Taiwan, R.O.C.

Prüfbericht - Nr.: 11032874 011

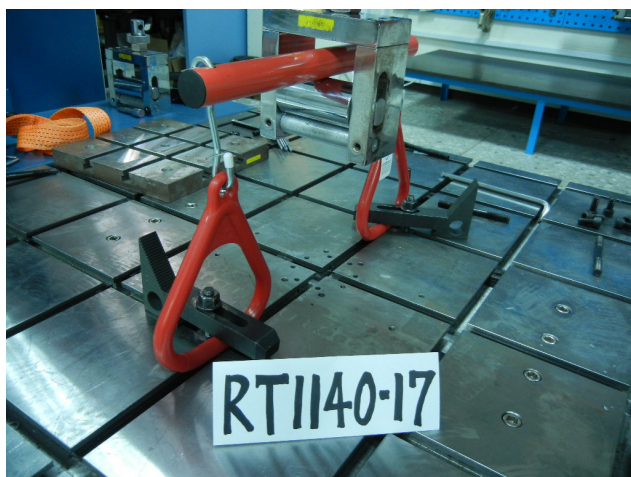
Picture 1

Clause	Requirement	Remarks	Verdict
1	Pulling test Check the breaking force for the sample.	By reaching force 3290 N (335 kg), the sample is strongly deformed and lose its function. The test setup and result please refer to picture 1 and 2.	--
